Manhole Inspection Summary

Manhole # S2111_019MH

Insp Date: **5/5/08 9:33 AM**

Location Address: **2701 rittenhouse rd**

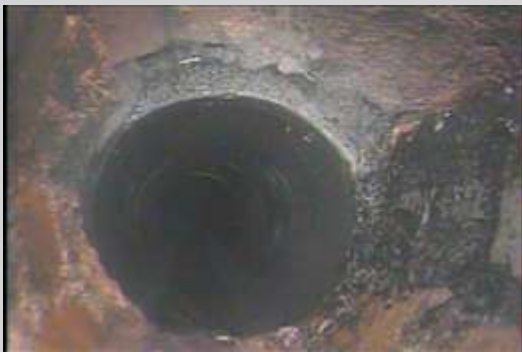
12 O'Clock Outflow

8 in. Circular Gravity Sewer
Pipe Out @ 12 O'Clock

Pipe Height: **8.4** (in.) Rod and Bar (Angled)
Pipe Material: **Clay** ☐ Pipe Lined
Invert Depth: **9.20** (ft.) Flow Characteristics: **Slow**
Deposits: ☒ None ☐ Mud ☐ Sludge ☐ Debris ☐ Grease
Silt Depth: **0** (in.) Deposits Extent:
Infiltration: **None** Pipe Seal Cond: **Sound**

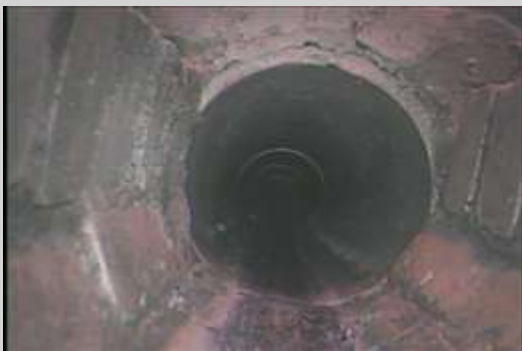
6 O'Clock Inflow

8 in. Circular Gravity Sewer
Pipe In @ 6 O'Clock

Pipe Height: **8.4** (in.) Rod and Bar (Angled)
Pipe Material: **Clay** ☐ Pipe Lined
Invert Depth: **8.98** (ft.) Flow Characteristics: **Slow**
Deposits: ☒ None ☐ Mud ☐ Sludge ☐ Debris ☐ Grease
Silt Depth: **0** (in.) Deposits Extent:
Infiltration: **None** Pipe Seal Cond: **Sound**

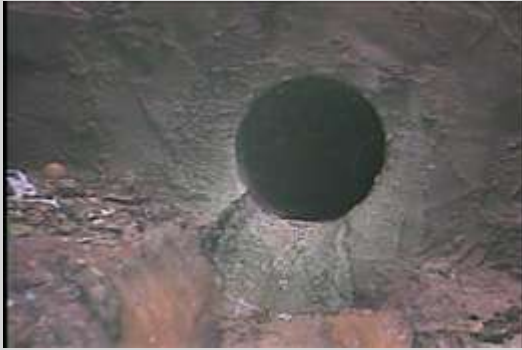
9 O'Clock Inflow

6 in. Circular Gravity Sewer
Pipe In @ 9 O'Clock

Pipe Height: **6** (in.) Rod and Bar (Angled)
